# Town of Chester Road Erosion Inventory 2015

Completed by Southern Windsor County Regional Planning Commission and the Town of Chester

Fieldwork completed October 2015

Report last revised January 19, 2016

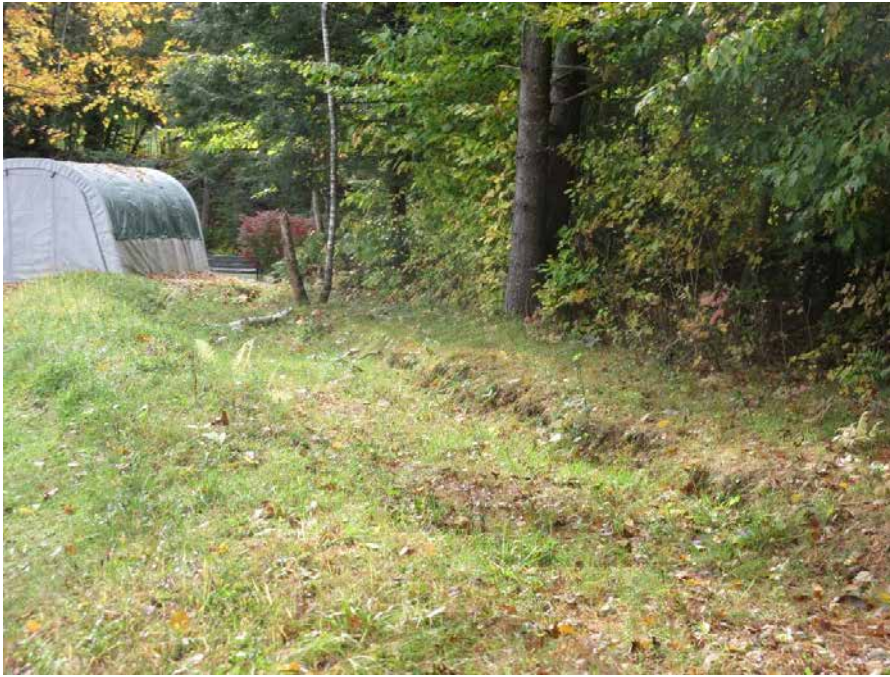
Top left: Chute that connects base of unpaved road to the nearby stream.

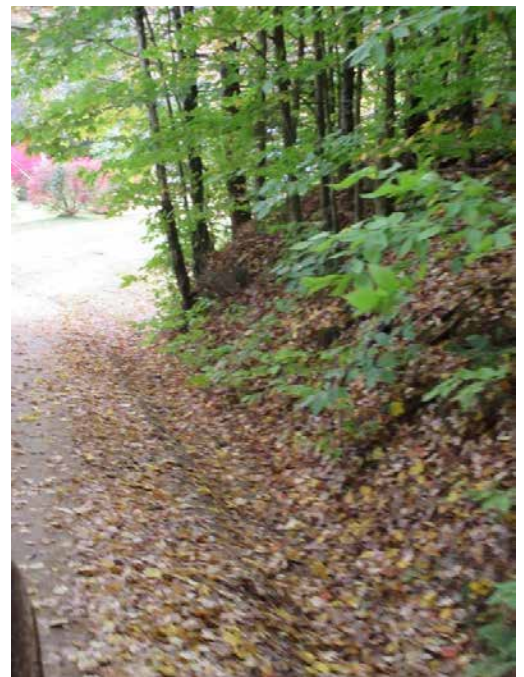
Top right: Ditch on south side of Marshall Road that carries approx. 90% of road runoff

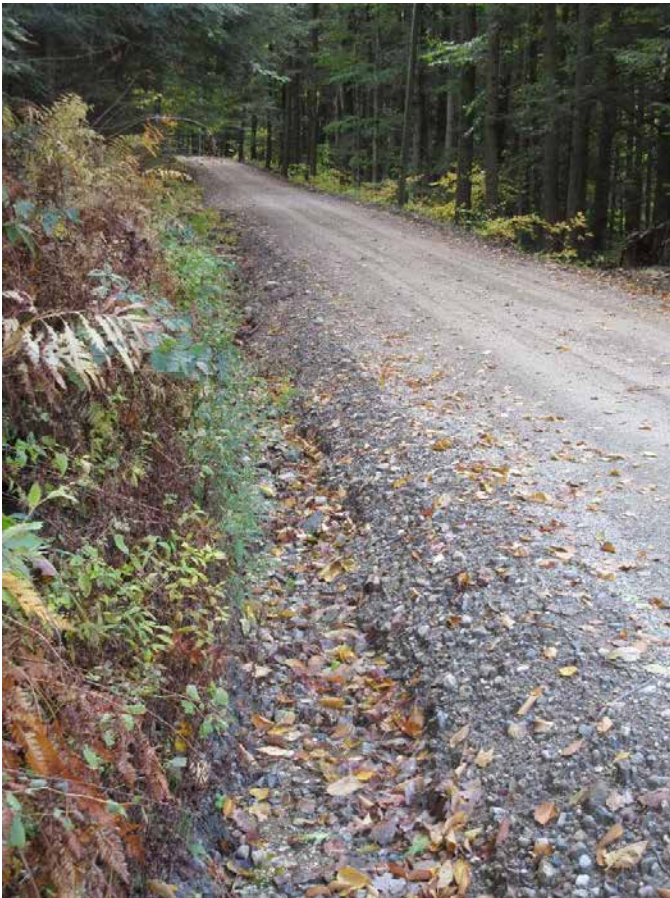
Bottom Left: Looking up along the upslope side of the road.

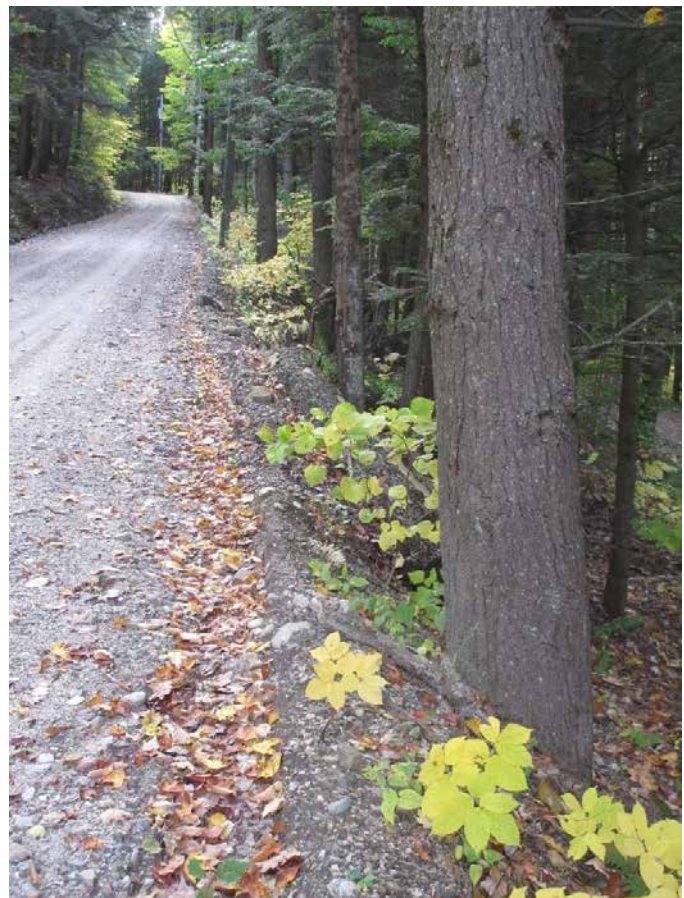
Bottom Right: Looking up the downslope side of the road which includes a small berm.

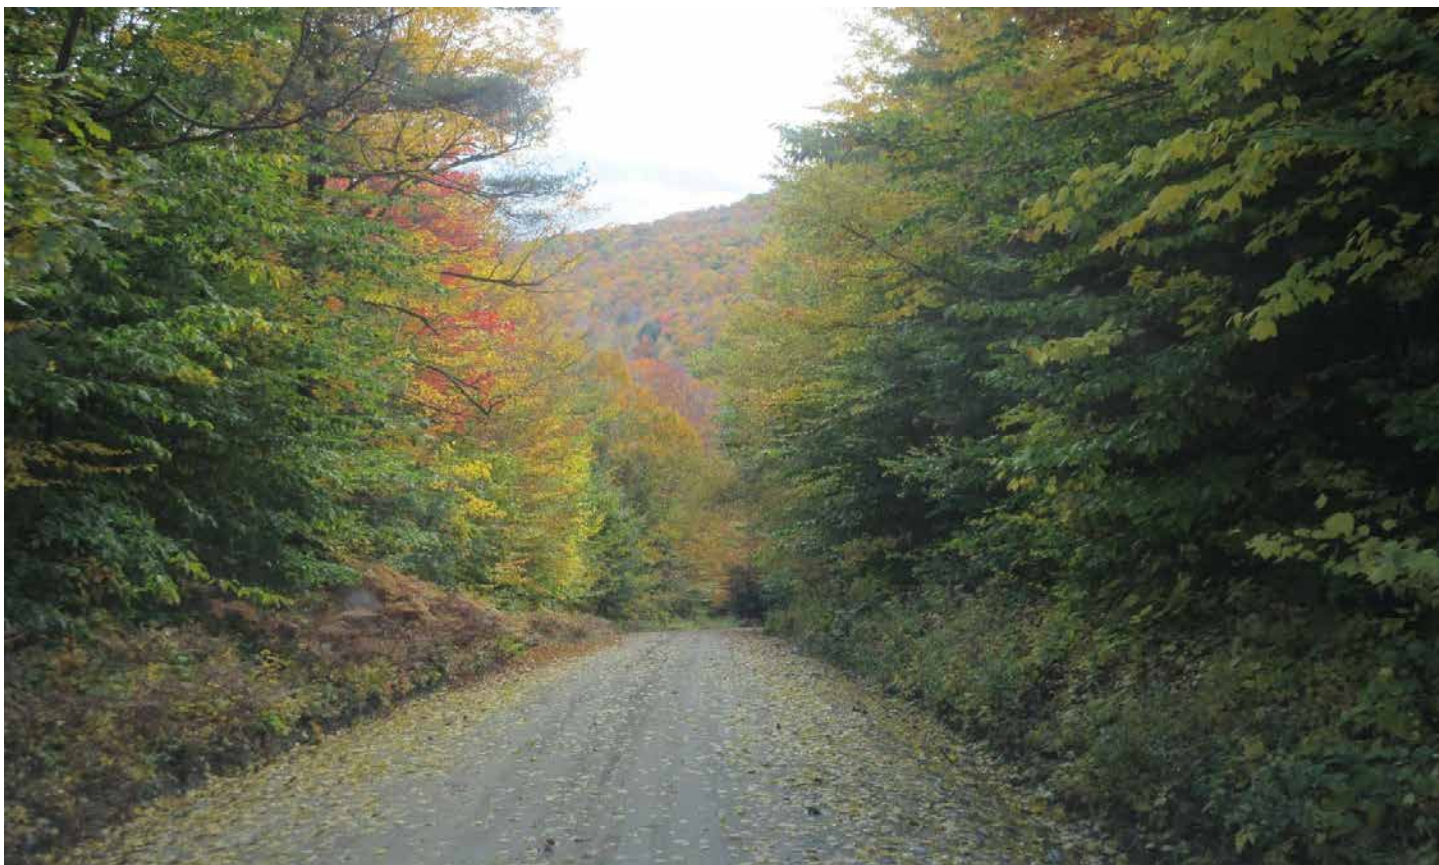
- Very steep roadway.
- Ditches need improvement.
- Area does not have a water quality issue as the water leeches into the woods before it reaches the closest stream.

Top: Looking down Miner Road.

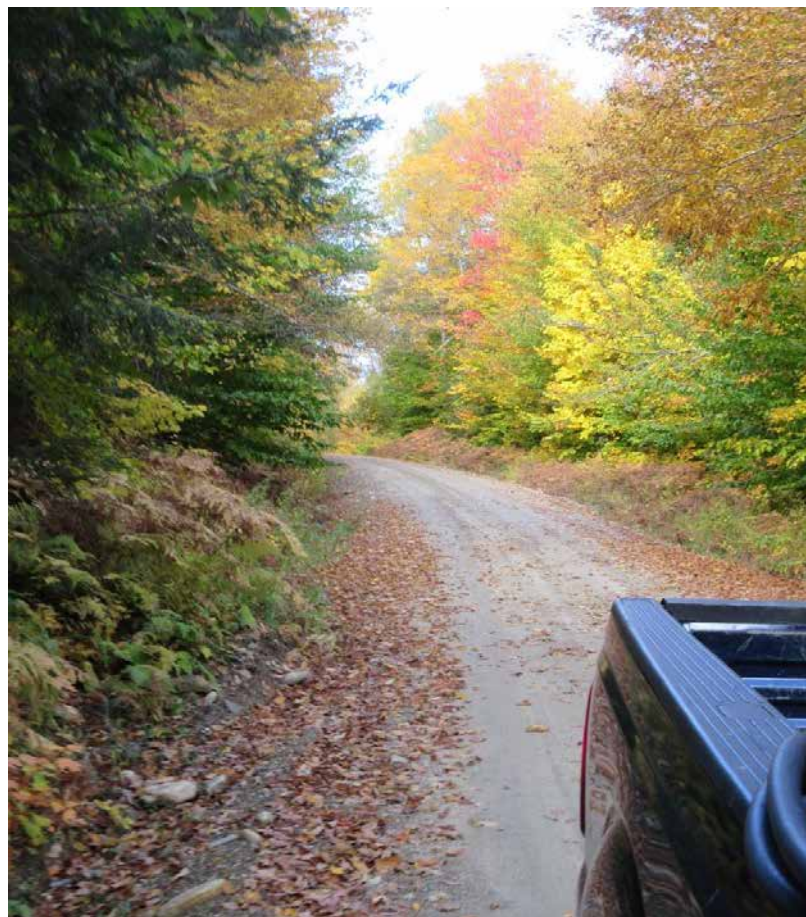
Bottom: Looking up Miner Road

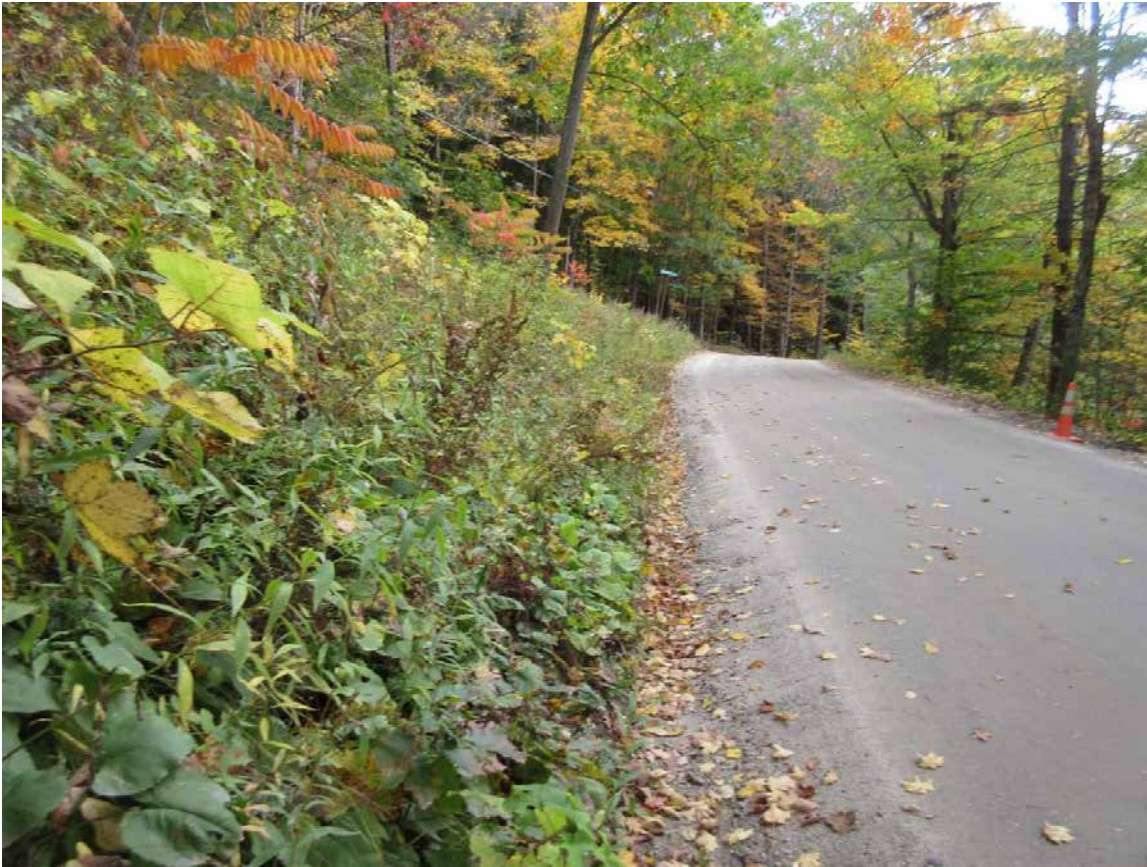
Top: North side of road,  
looking east towards  
Suursoo Road  
intersection (at crest of  
road)

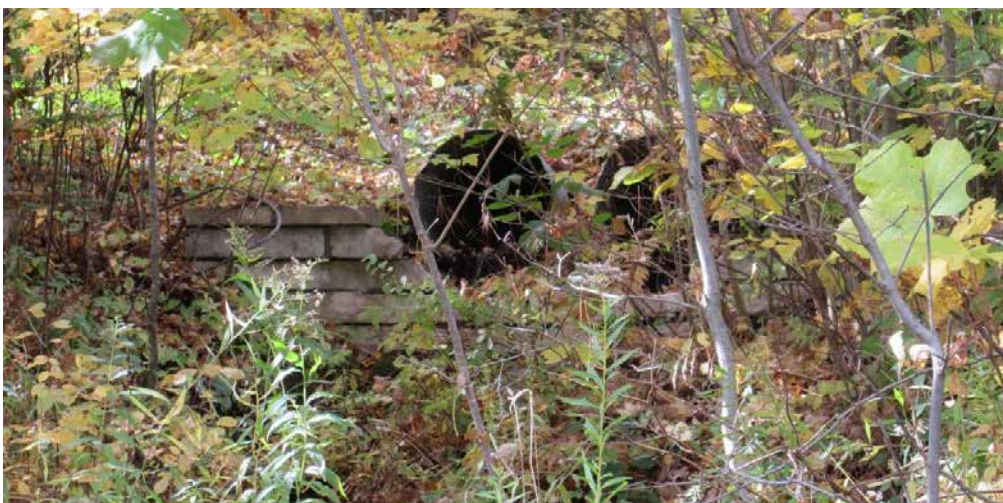
Bottom: Detail of double culvert outlet as viewed from VT-103.

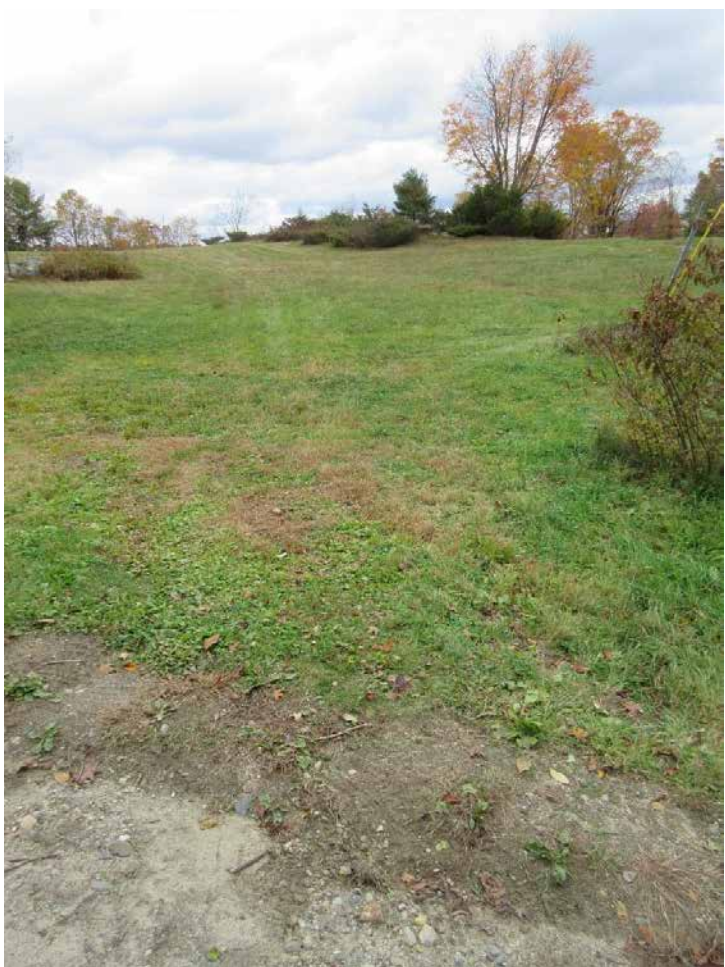
- Water runs off adjacent fields into the roadway, causing erosion.

Top: Fields above Gould Road that have lots of runoff into the road.

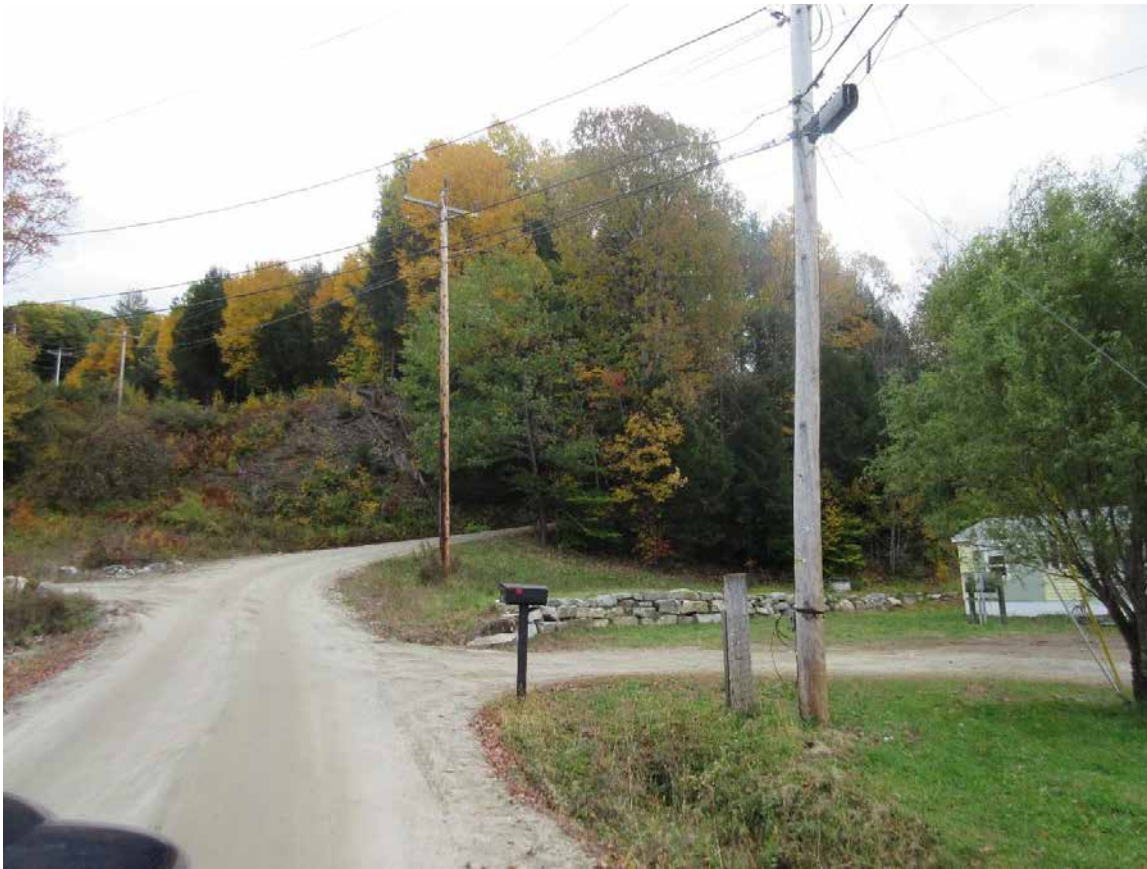
- Very steep road with drainage issues.
- Road is currently graded with a cross-slope so about 90% of stormwater goes into the ditch on the south side of the roadway.

Top: Bottom of big hill on Mineral Springs Road. Hill starts near the corner.

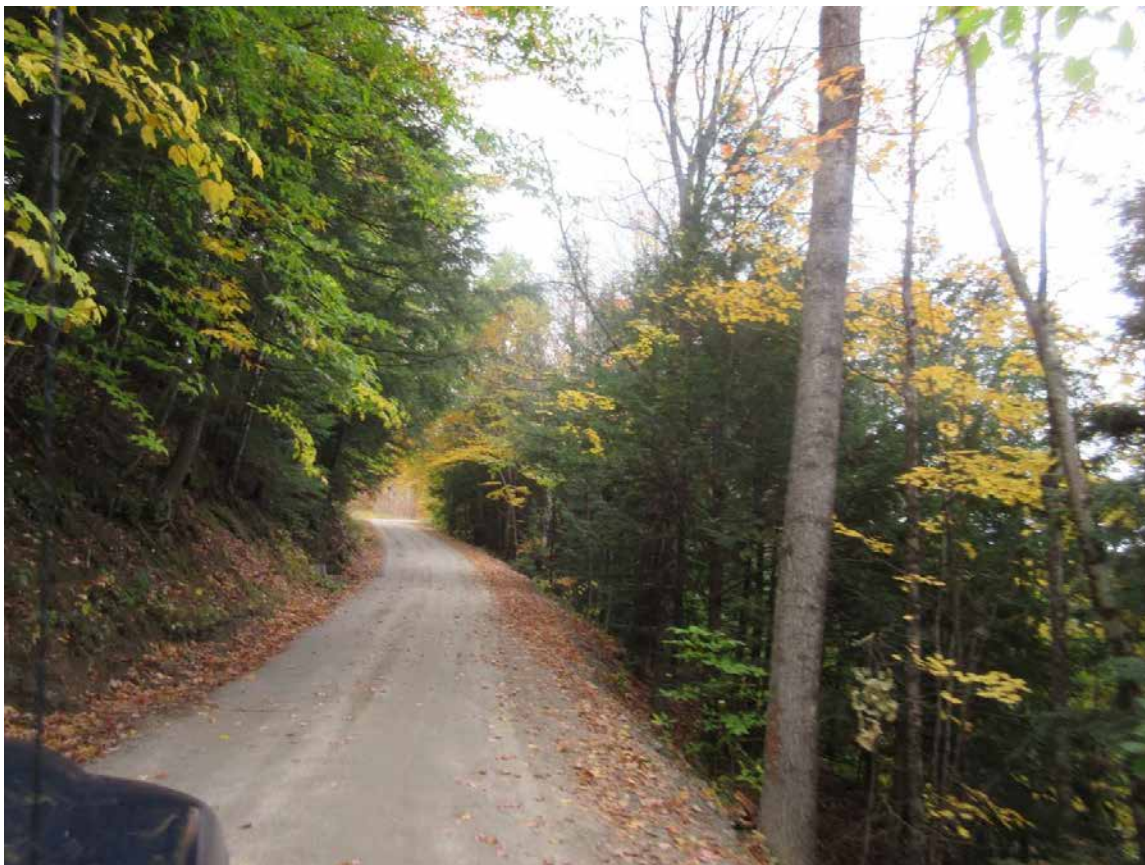
Bottom: Near bottom of big hill on Mineral Springs Road
