Office of Highway Safety

Road Safety Audit Review - FINAL

Town:	Londonderry	Date Reviewed:	October 8, 2015
Route:	VT 100, Middletown Rd and Main St	Mile points:	Area of mm 2.99

The location of this RSAR is the intersection of VT 100, Middletown Road and Main Street in South Londonderry.

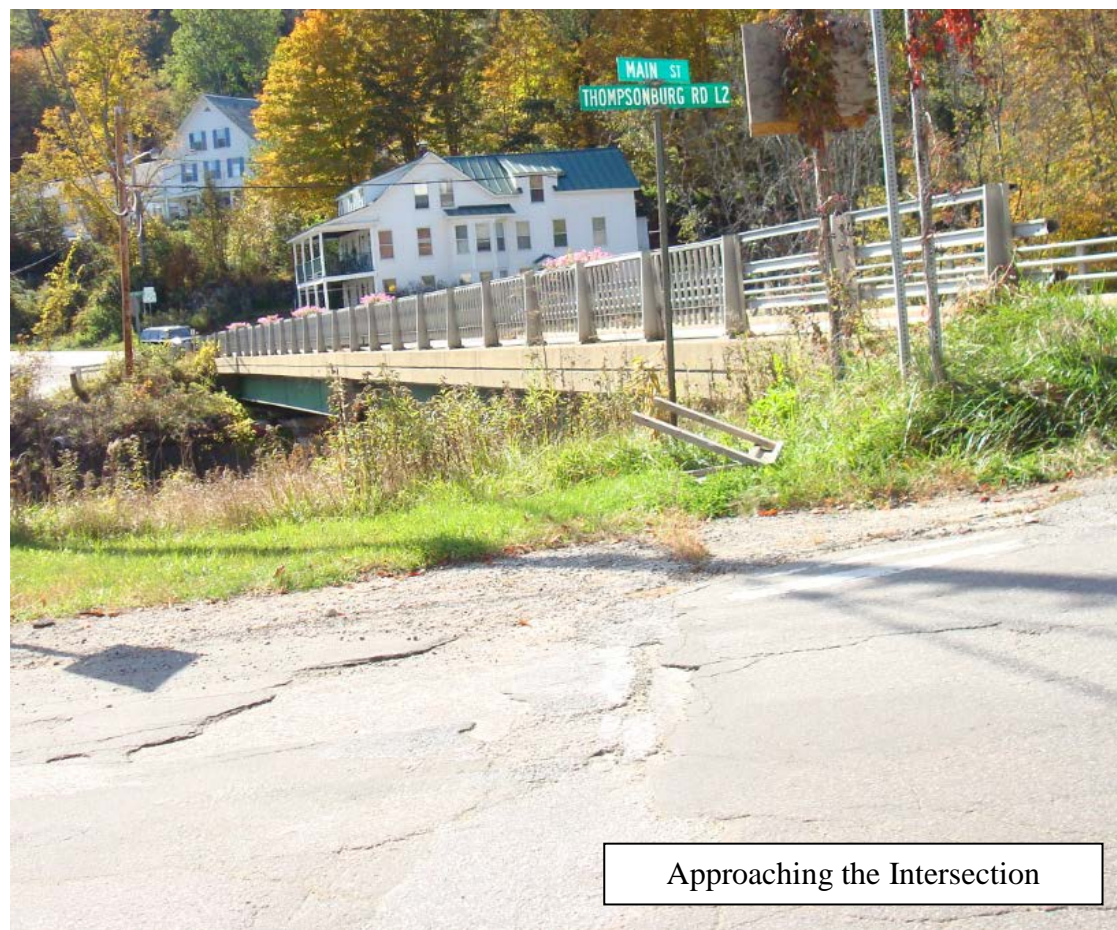
Approaching the Intersection

There is poor corner sight distance when stopped on the Main St approach and looking towards the VT 100 northbound approach (i.e., when looking to the left).

This poor condition is mainly caused by the presence of the bridge railing which makes it very difficult to see oncoming traffic through it as one approaches the intersection.

It is questionable whether the presence of the flower boxes contributes to the limited visibility and if it is possible to see the top of a small car without them being there.

Brush in this quadrant including the vine that is growing up the sign posts is also somewhat distracting.

Immediate to Short Term Actions (up to a year)

Install a "Main St" street name sign above the stop sign on Main St.

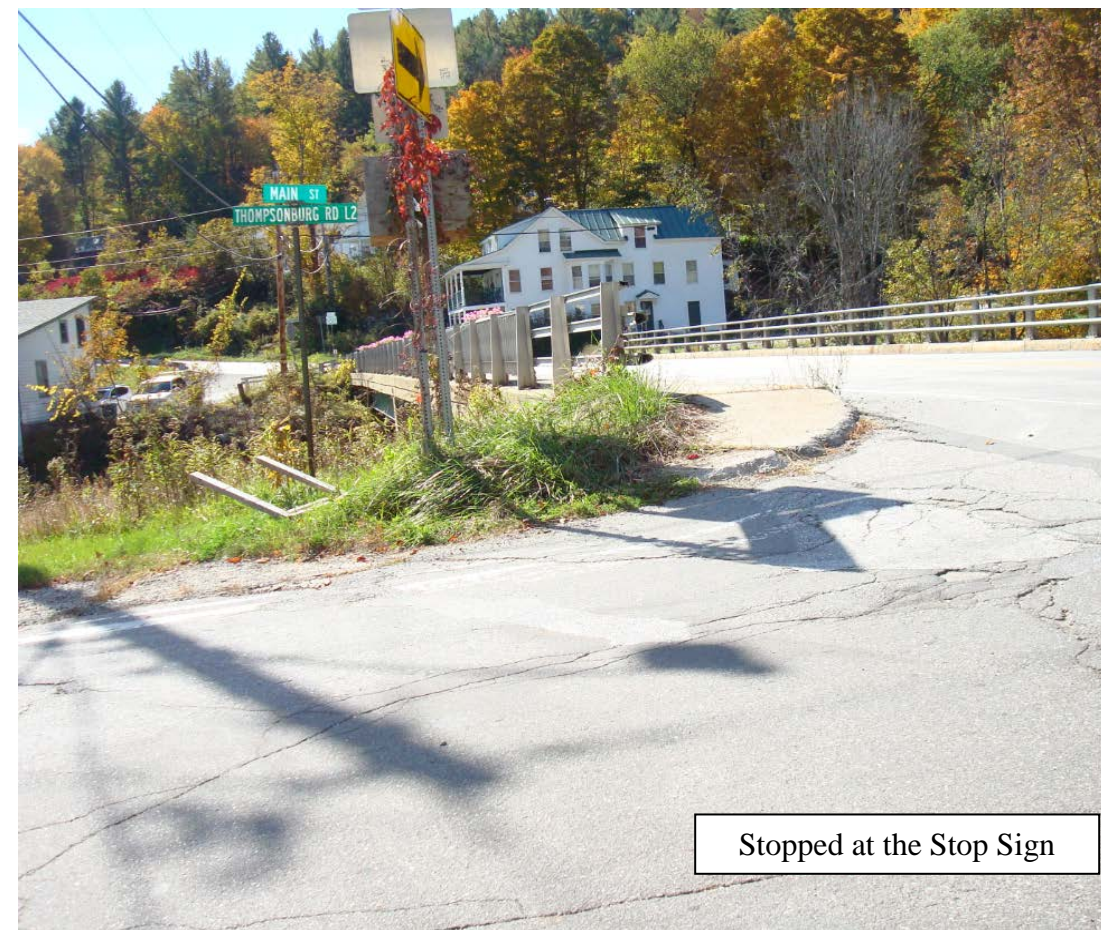
Stopped at the Stop Sign

It is also difficult to see oncoming traffic when stopped at the stop sign. It is only when the nose of the vehicle is in the road that an operator can start seeing traffic.

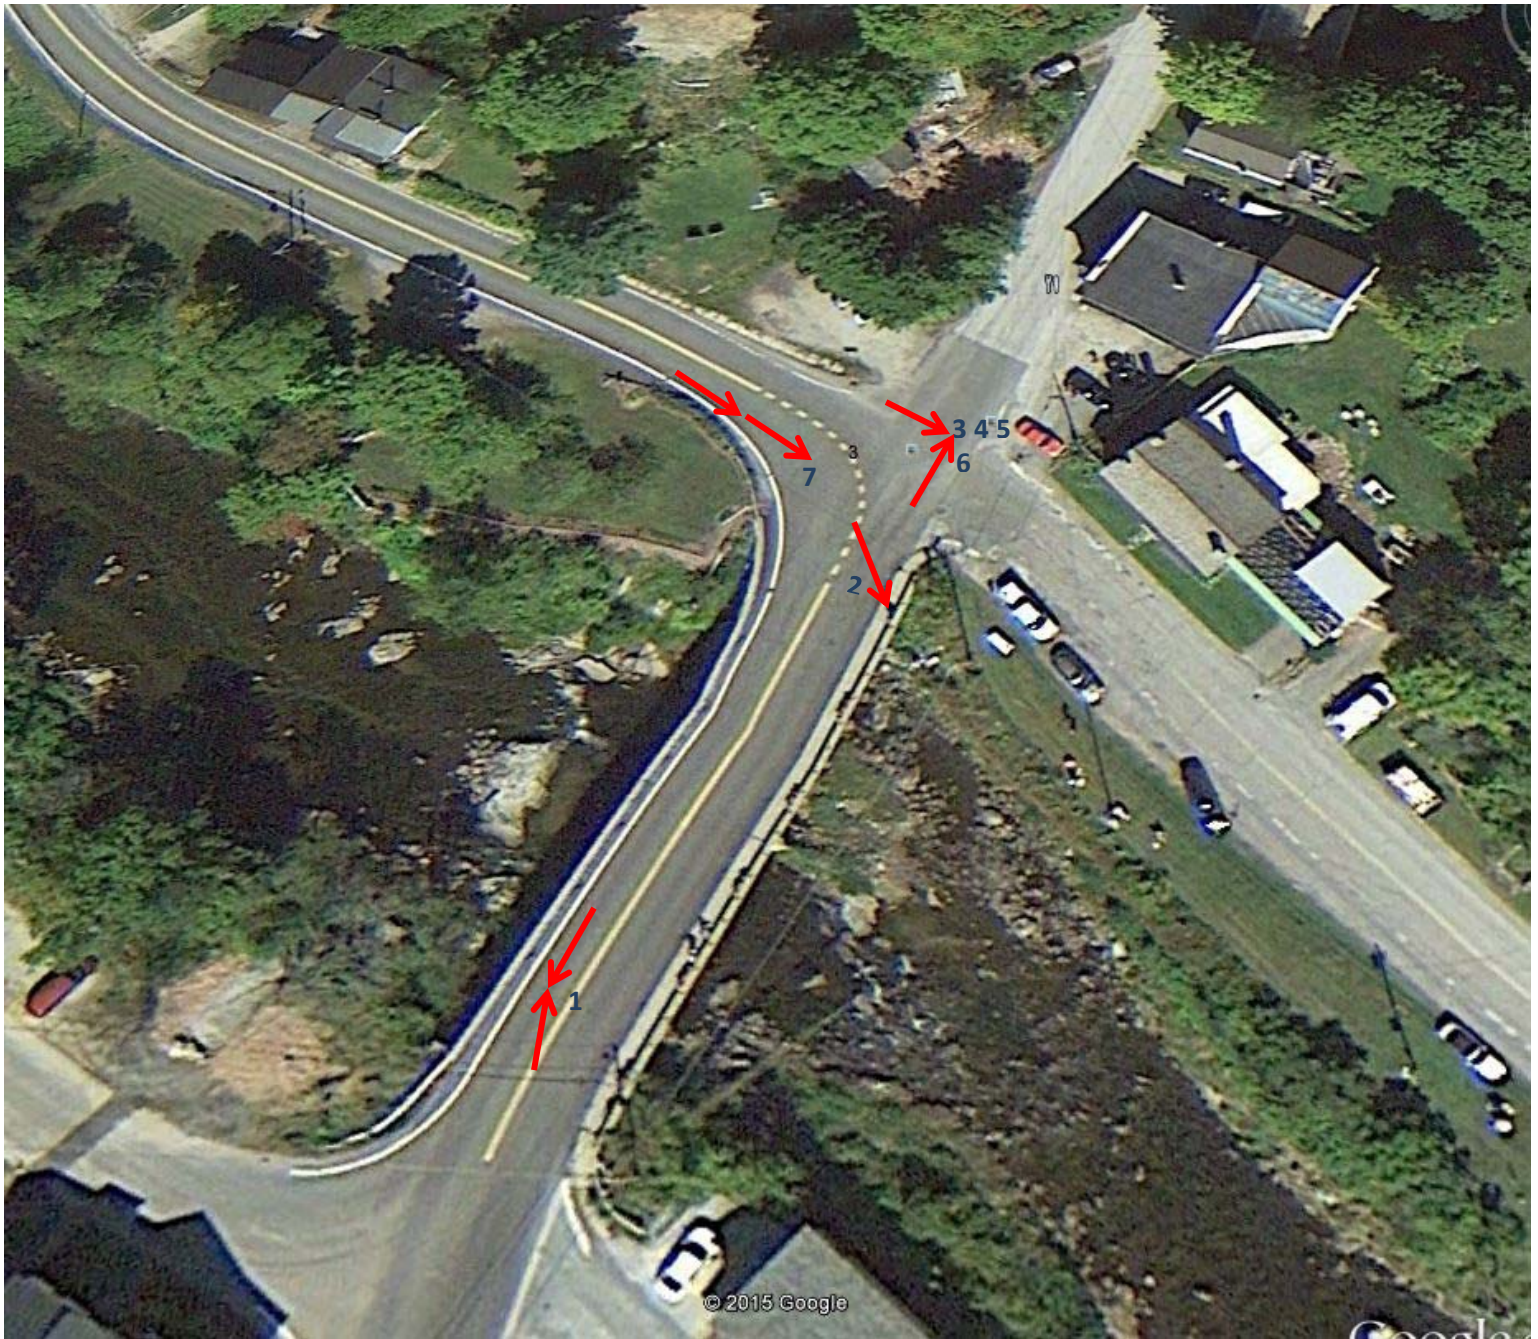
Collision Diagram

There were a total of three crashes at this intersection between 2010 and 2014. Three additional crashes took place in 2015.

All the crashes that took place at this intersection involved a vehicle that was traveling southbound on VT 100.

The main crash pattern at this intersection is a right angle collision (this corresponds to four of the six crashes at this intersection). Seventy-five percent of the crashes involving this type of crash occurred when a southbound vehicle on VT 100 continued straight onto Main St without yielding to oncoming traffic from the right (VT 100 northbound). In one of the crash reports, the operator at fault specifically stated that he felt that he had the right-of-way.

A second crash pattern of interest is a southbound vehicle that loses traction and control on an icy road surface. Of the six crashes investigated at this intersection, an icy road surface was the contributing factor in three crashes. These crashes were not concentrated in a particular year but happened over several years (one each in 2013, 2014 and 2015), indicating a more recurring issue.
