PCB Testing at Green Mountain Union High School - Updates

Department of Environmental Conservation (DEC)

June 19, 2025

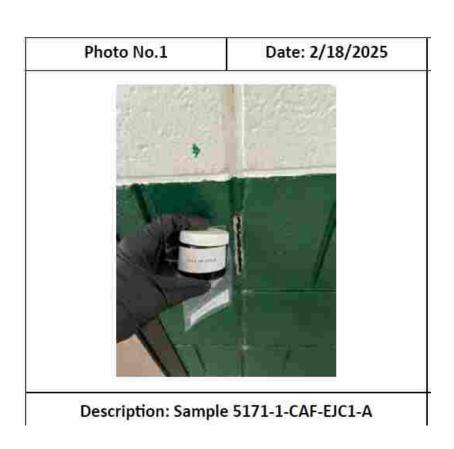
- JTC (the environmental consultant)
 has completed 3 site investigation
 efforts to evaluate suspect
 materials:
 - Caulk around door frames and windows, and expansion joints (2.2 mg/kg - 460,000 mg/kg).
 - Mastic under carpets and floor tiles (4.7 mg/kg - 2200 mg/kg).
 - Wall paint (4.8 mg/kg 99 mg/kg).
