# Town of Chester Road Erosion Inventory 2015

Completed by Southern Windsor County Regional Planning Commission and the Town of Chester

Fieldwork completed October 2015

Report last revised January 19, 2016

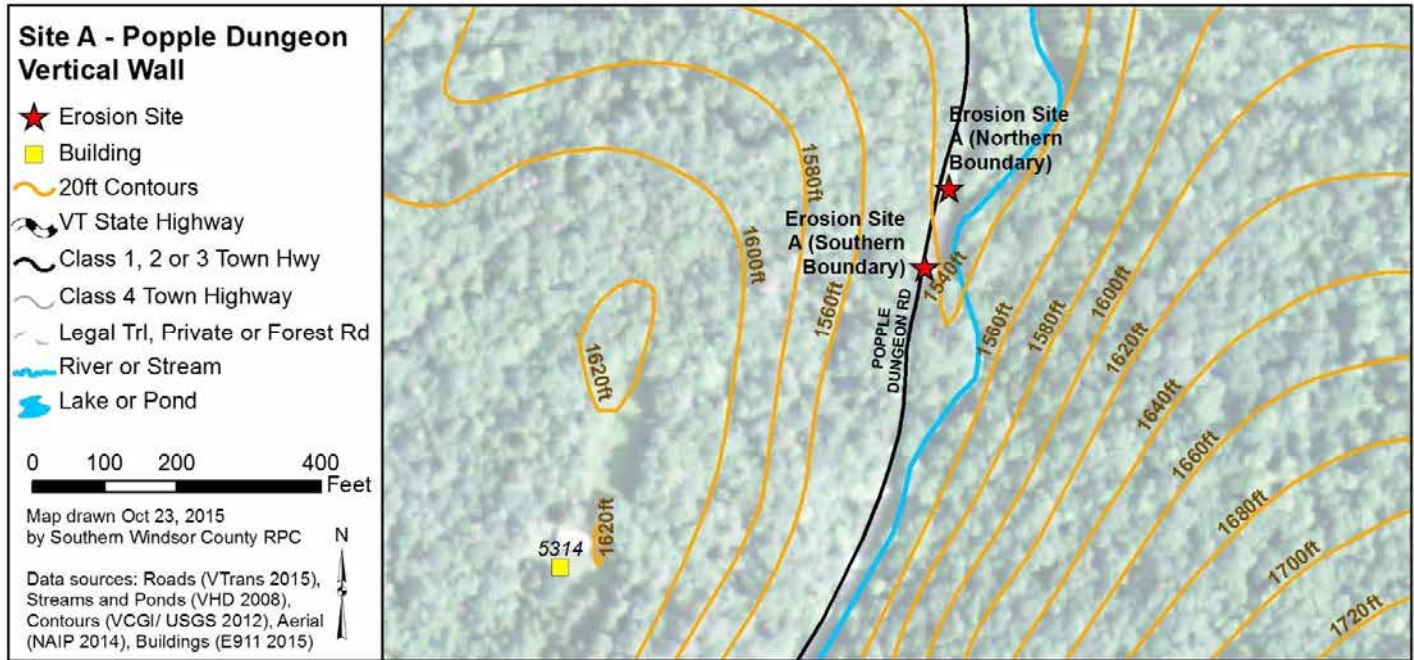
### Site Map

- Stream right next to the road on a river bend.
- Road has issues with flash flooding (most recently 2011 and 2014) and beaver dams (every few years).
- Currently has 6ft concrete blocks to keep the bank vertical (160ft long, 14ft high), but that is not good hydrologically and not a permanent fix.
- Road washes out regularly and the existing concrete blocks will eventually fail.
- Site also needs guard rails, but there currently is not sufficient space.

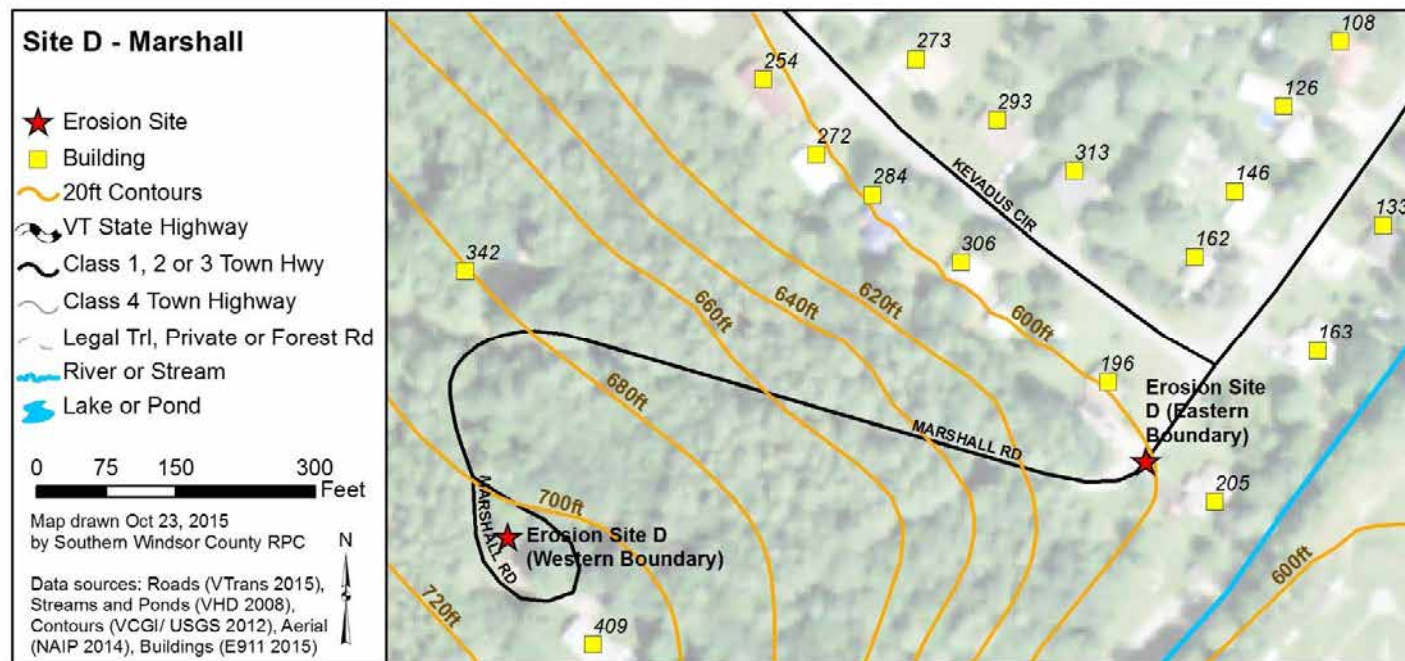
### Site Map

- Water runs down a steep hill onto the residential development below (Marshall Road and Kevadus Circle).
- From about halfway down the hill the unpaved roadway has been graded with a cross-slope so that:
  - 90% of the water drains into the ditch on the south side which then runs into a chute which flows into a stream. This chute has a good amount of distance and grass between the roadway and the stream to prevent water quality issues.
  - 10% of the water drains into the ditch on the north side which then runs through a short amount of very steep woodland into the residential development below. This development does not have any storm water capacity and the water table is very close to the surface there.

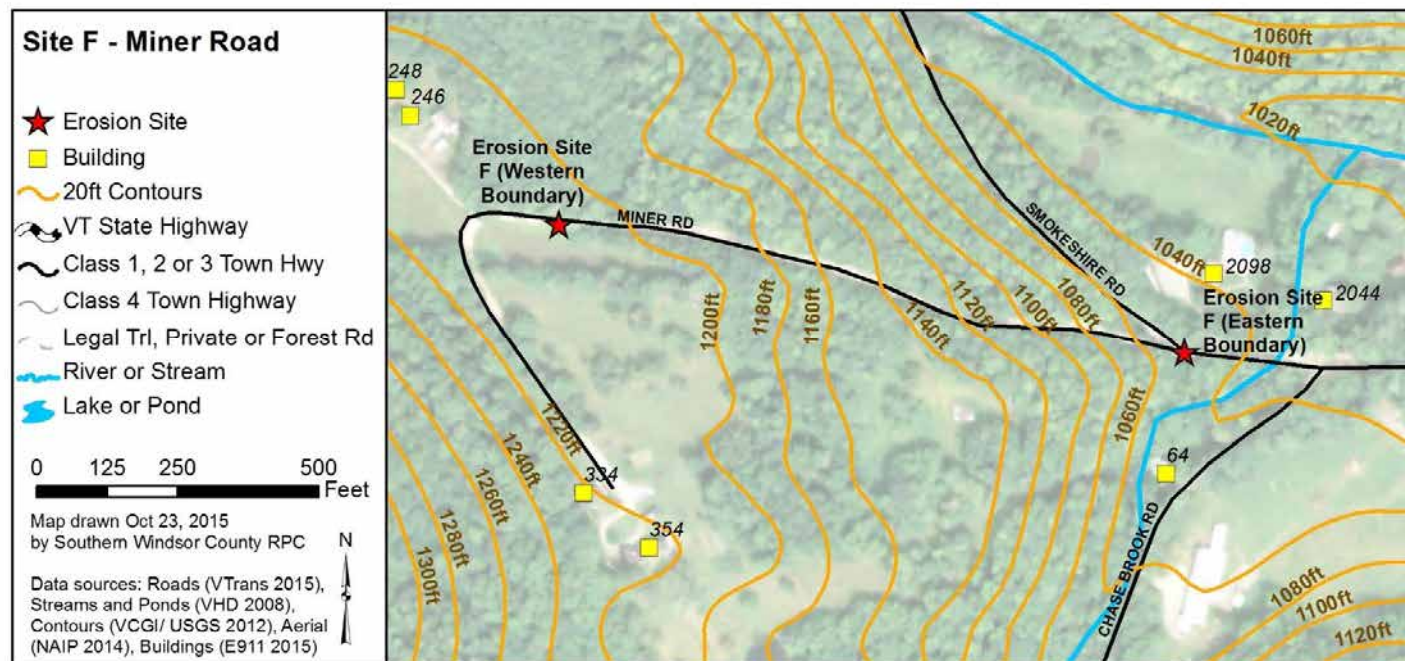
### Site Map

- Very steep roadway.
- Ditches need improvement.
- Area does not have a water quality issue as the water leeches into the woods before it reaches the closest stream.

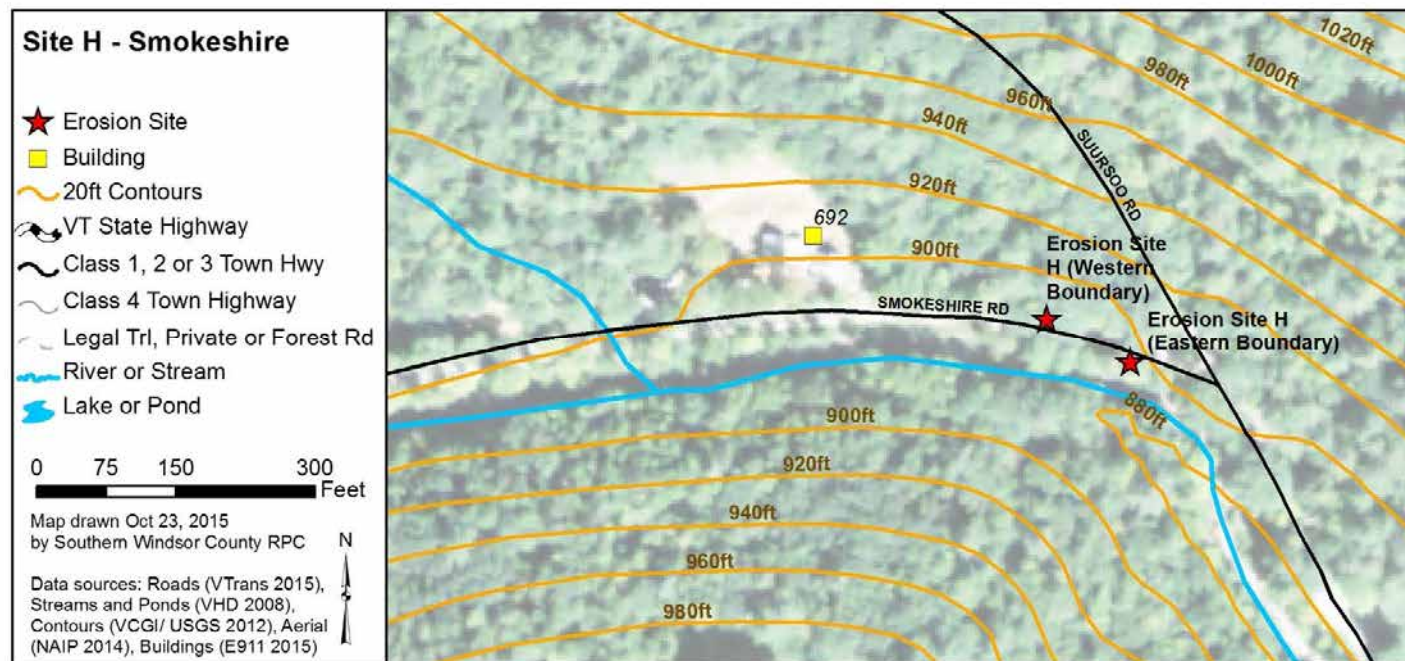
### Site Map

- Road edge starting to collapse and undermine right next to the stream. One very small section currently has issues, but problem will occur along far longer section of roadway before too long – only a few trees left holding the bank together.
- Steep (vertical) slope of approximately 15-20ft between road and river.
- Road cannot move very far away from the river as ledge is very close to the road edge, and there is another steep road paralleling the road just above it (Suursoo Road) which would have to be relocated if Smokeshire Road was relocated.

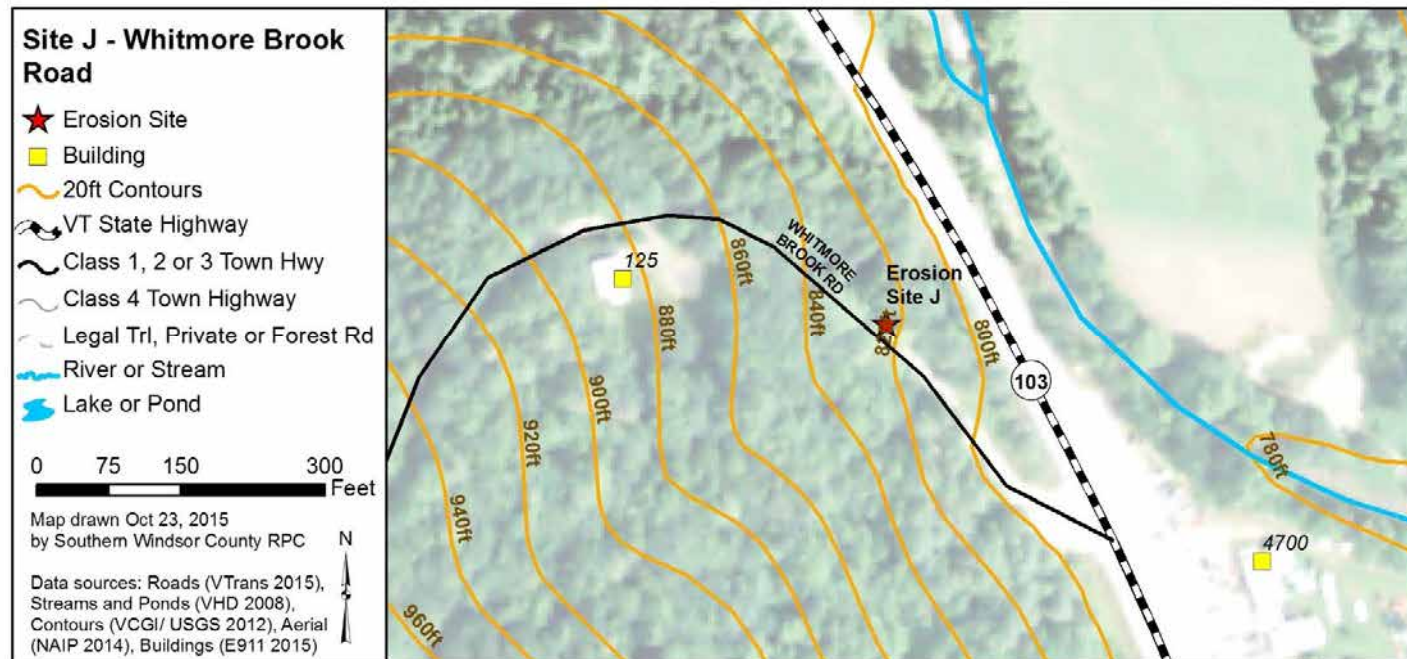
### Site Map

- Double culverts (both 24 inch diameter) do not adequately handle water – particularly during icy conditions.
- Complex situation including a steep bank with waterfalls and pools below – which end right next to VT-103.
- Culverts have marble headers – which are not found anywhere else in town – except within VT-103 ROW. Unknown reason

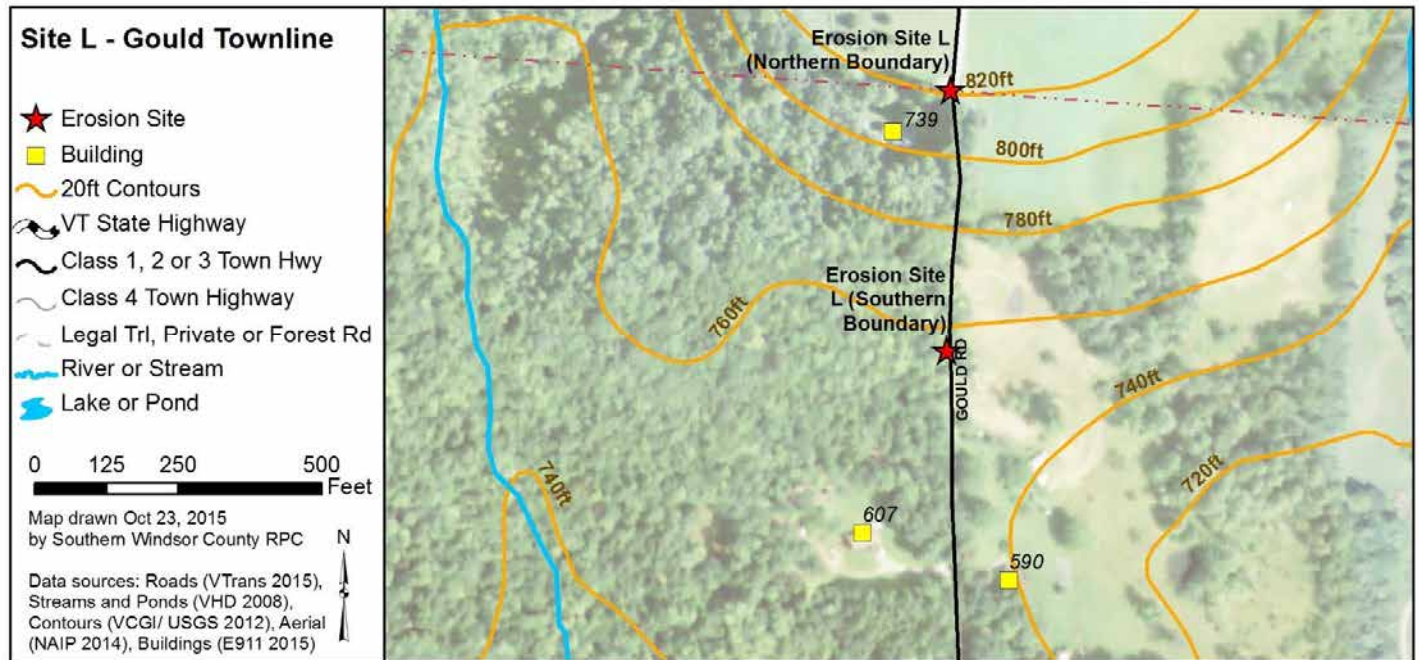
### Site Map

- Very steep road which is very narrow (trees and walls on either side) and has trouble with road erosion.
