Office of Highway Safety

Road Safety Audit Review - FINAL

Town:	Londonderry	Date Reviewed:	October 8, 2015
Route:	VT 100, Middletown Rd and Main St	Mile points:	Area of mm 2.99

The location of this RSAR is the intersection of VT 100, Middletown Road and Main Street in South Londonderry.

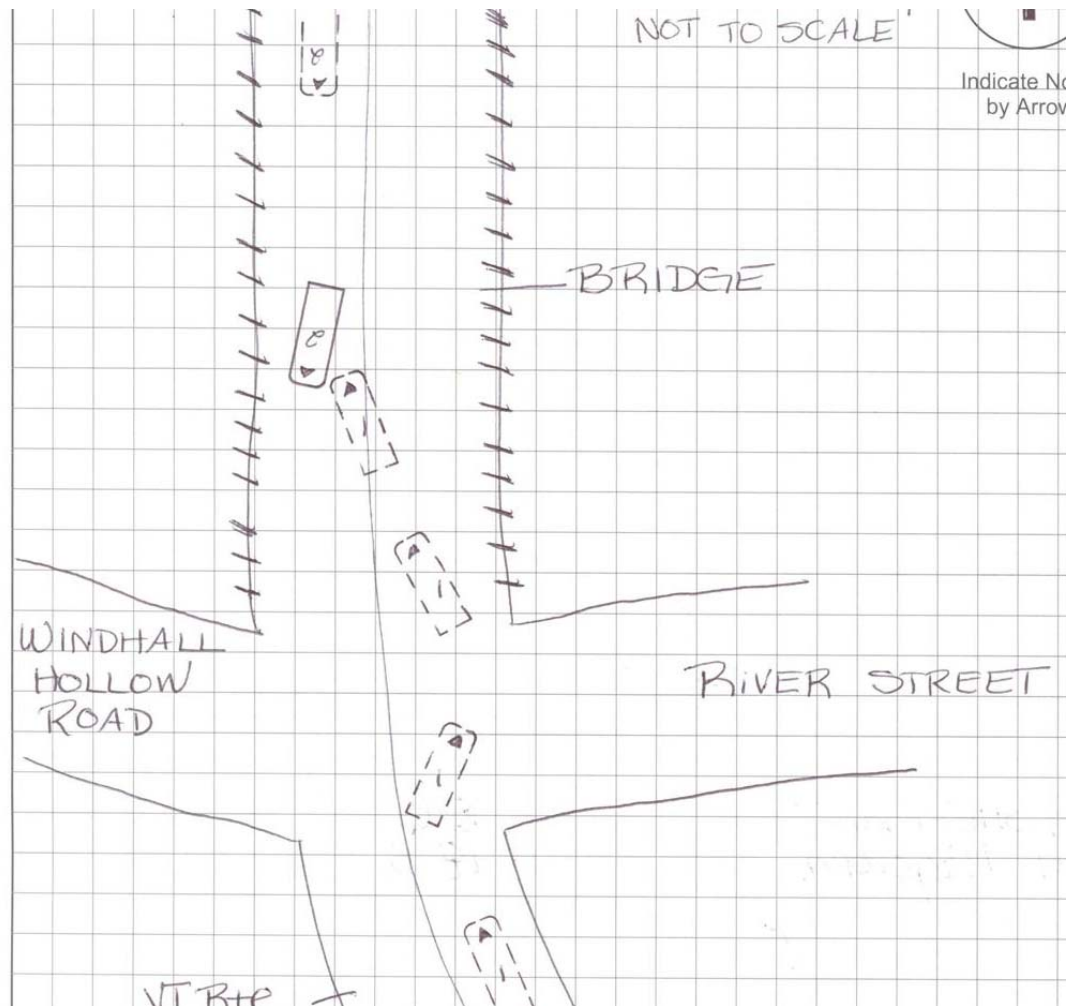
On 01/04/14, at approximately 1246 hours, two-vehicle crash on the bridge on Rte 100 in the town on S. Londonderry. There were unknown injuries. Weather at the time was sunny with precipitation. The roadways were snow covered and slippery. Op 1 advised he was traveling down the hill at a speed believed to be 20 miles an hour when he lost control of his vehicle and then collided with a vehicle traveling in the opposite direction. Operator #2 was traveling south over the bridge on Rte 100 when she observed the oncoming vehicle start to skid out of control. Investigation revealed that op 1 was traveling north on Rte 100, down a steep hill in the town of S. Londonderry just south of the West River bridge. Op 1's vehicle started to skid out of control into the southbound lane subsequently hitting Op 2 vehicle.

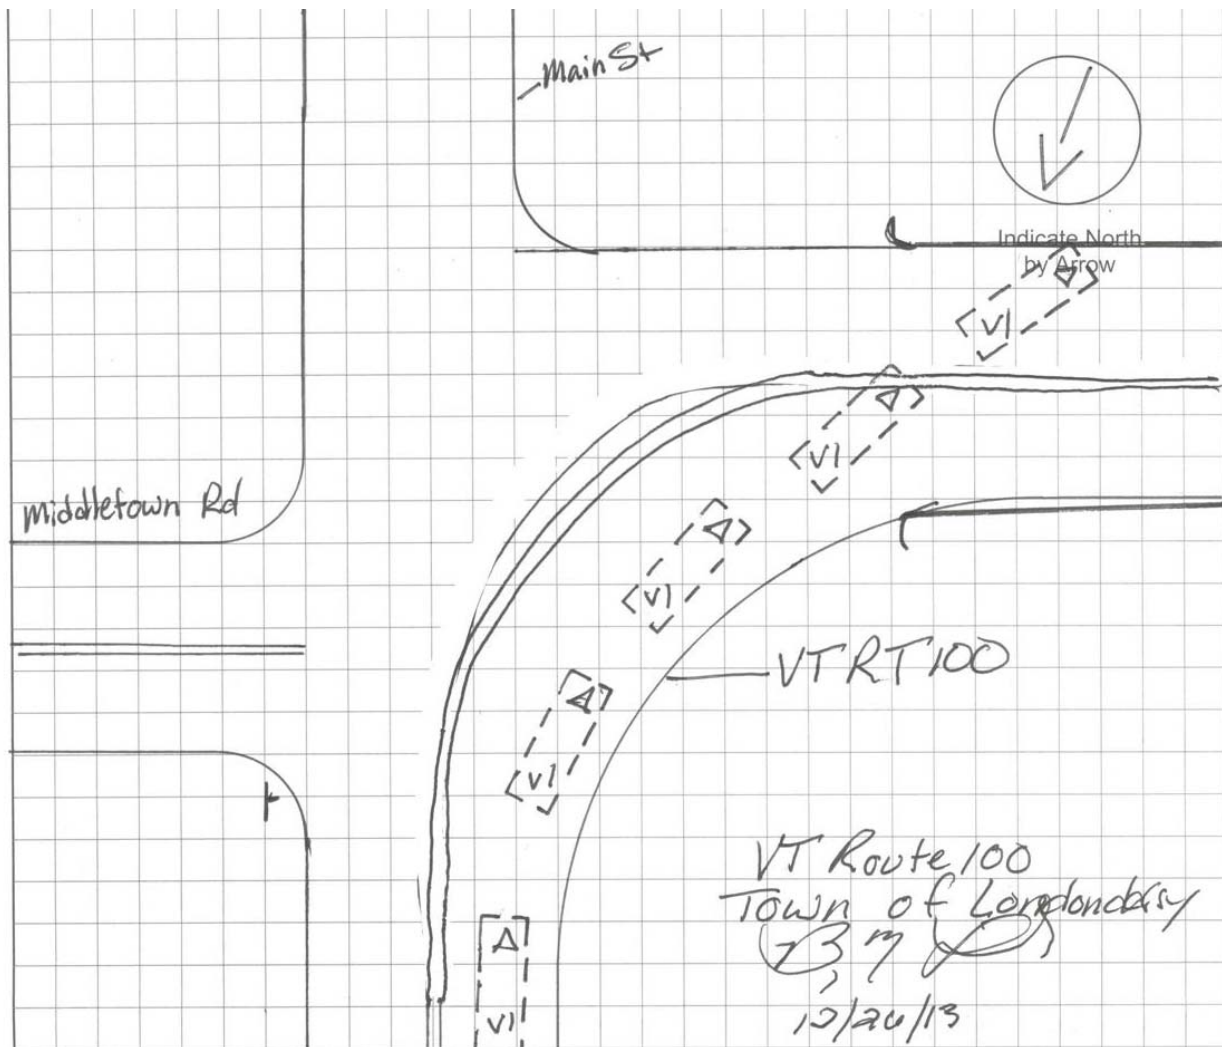
On December 26, 2013 at approximately 1207 hours, a one car motor vehicle crash located at the intersection of Vermont Route 100 and Main Street, in the Village of South Londonderry. The weather at the time consisted of fair skies and the blacktop roadway was icy in spots. Op 1 advised she was traveling southbound at approximately 20 miles per hour, on Vermont Route 100. Operator # 1 advised Vehicle # 1 lost traction causing Vehicle # 1 to cross the center line and crash into a guardrail of the bridge. Operator # 1 advised she was uninjured. Investigation revealed Vehicle # 1 was traveling Southbound on Vermont Route 100. Vehicle # 1 lost traction causing Operator # 1 to lose control of her vehicle and cross the center line and crash into a guardrail of the bridge.

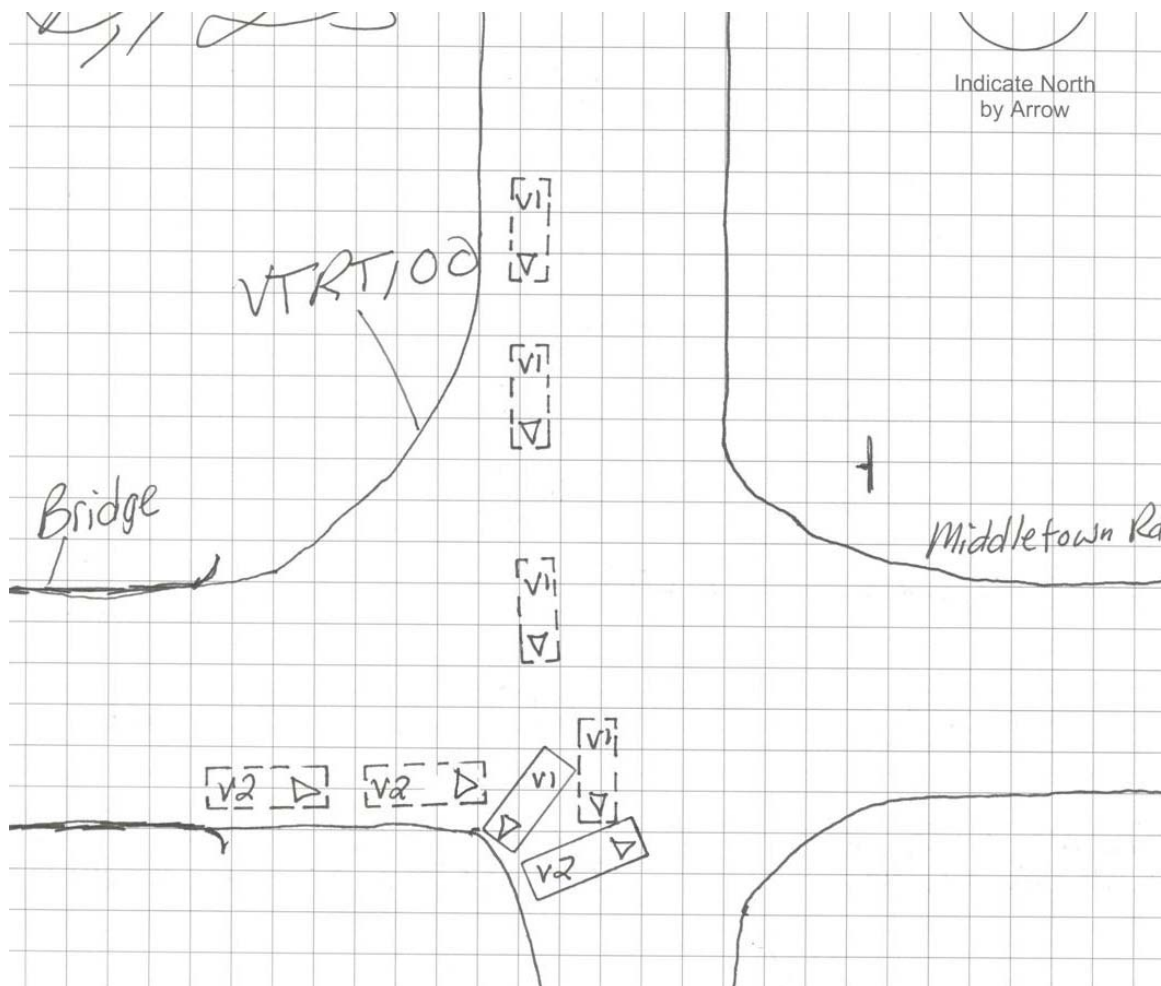
On January 3, 2014 at approximately 0916 hours, two-car motor vehicle crash located on Route 100, at the intersection of Main Street. The weather at the time consisted of clear skies and the gravel roadway was icy. Operator # 1 advised he was traveling southbound on Route 100 at approximately 15 miles per hour, when he lost traction from the icy road conditions, causing Vehicle # 1 to crash into Vehicle # 2. Operator # 1 advised he was not injured. Operator # 2 advised he was traveling northbound on Route 100 at approximately 5 miles per hour, preparing to turn right onto Main Street. Operator # 2 advised as he was making the right turn, he observed Vehicle # 1 lose control of his vehicle and crash into Vehicle # 2. Operator # 2 advised he was not injured. Investigation revealed that Vehicle # 1 was traveling southbound on Route 100. As Vehicle # 1 was approaching the intersection of Main Street, Vehicle # 1 lost control and crashed into Vehicle # 2 while Vehicle # 2 was in the northbound lane of Route 100 and turning onto Main Street.

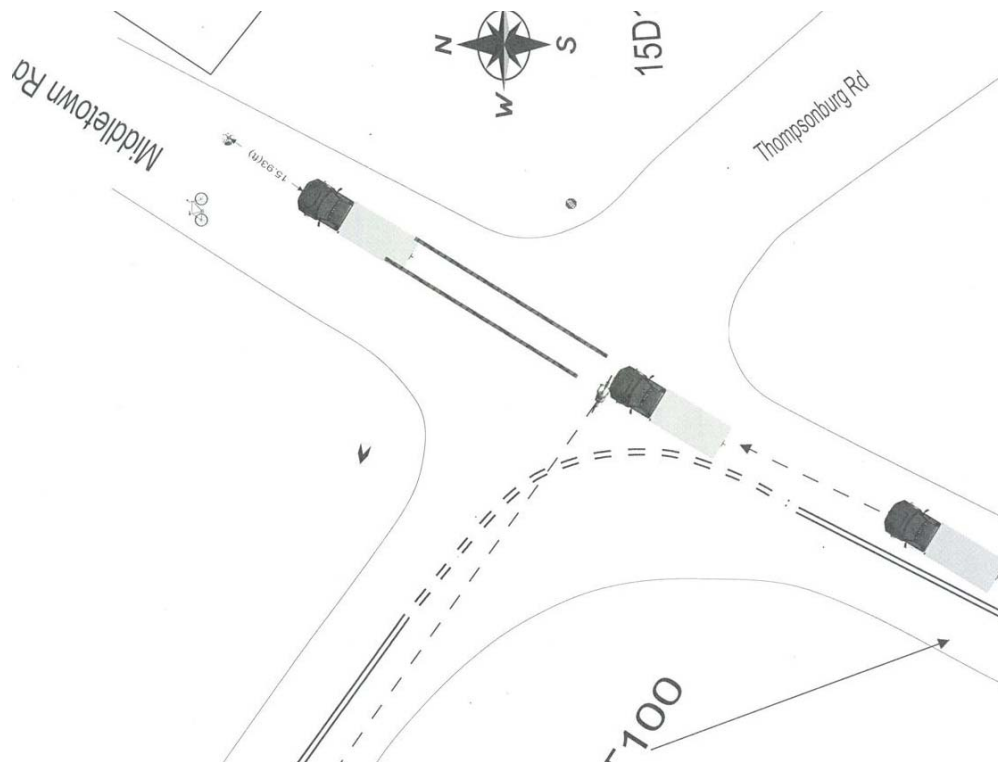
On 05/15/15 at approximately 1510 hours, a bicyclist versus truck crash at the intersection of Route 100 and Middletown. Op 1 advised she was travelling north on VT 100 and continuing straight at the intersection to travel onto Middletown Road. Said she was traveling approximately 25 to 28 mph and didn't see the bicyclist until he collided with the front left of her vehicle. Witness 1 was travelling in front of OP 1 and continued north on VT 100 at the intersection. She advised she saw the bicyclist travelling south on VT 100 entering the intersection without yielding to traffic. Witness 2 was following Op 1 and advised he saw the entire crash. He said it did not appear the bicyclist slowed or looked for oncoming traffic and attempted to cross VT 100 to continue on Thompsonburg Road. He said the bicycle was travelling quickly. Skid marks measured approximately 37'8" in length originated in the northbound lane of Route 100 and ended at the rear tires of vehicle #1. Utilizing the skid, the to stop formula and a friction coefficient of .76, the officer determined that the skid to stop speed would be approximately 29 MPH, which corroborated the statement of operator #1. On 05/16/15 officer spoke with the bicyclist's mother, he asked her what her son had said about the crash. She said that he was riding his road bike with the intention of traveling across Route 100 on to Thompsonburg Road. He said that he thought that the truck was slowing down but then sped up. On 05/19/15 son advised that he did not remember much about the crash but he did have a tracker app (Road Bike Pro) running which

indicated that the collision happened in his lane and he was going 7 MPH. Based upon the statements received and the physical evidence, specifically the skid marks left by vehicle #1, the officer believe that this crash occurred as a result of the bicyclist failing to yield to vehicle #1 as it was making way toward Middletown Road from the northbound lane of Route 100. It was the intention of the bicyclist to cross the northbound lane of Route 100 and travel east on Thompsonburg Road. Vehicle #1 was traveling north in the northbound lane of Route 100 and was intending to travel straight onto Middletown Road.

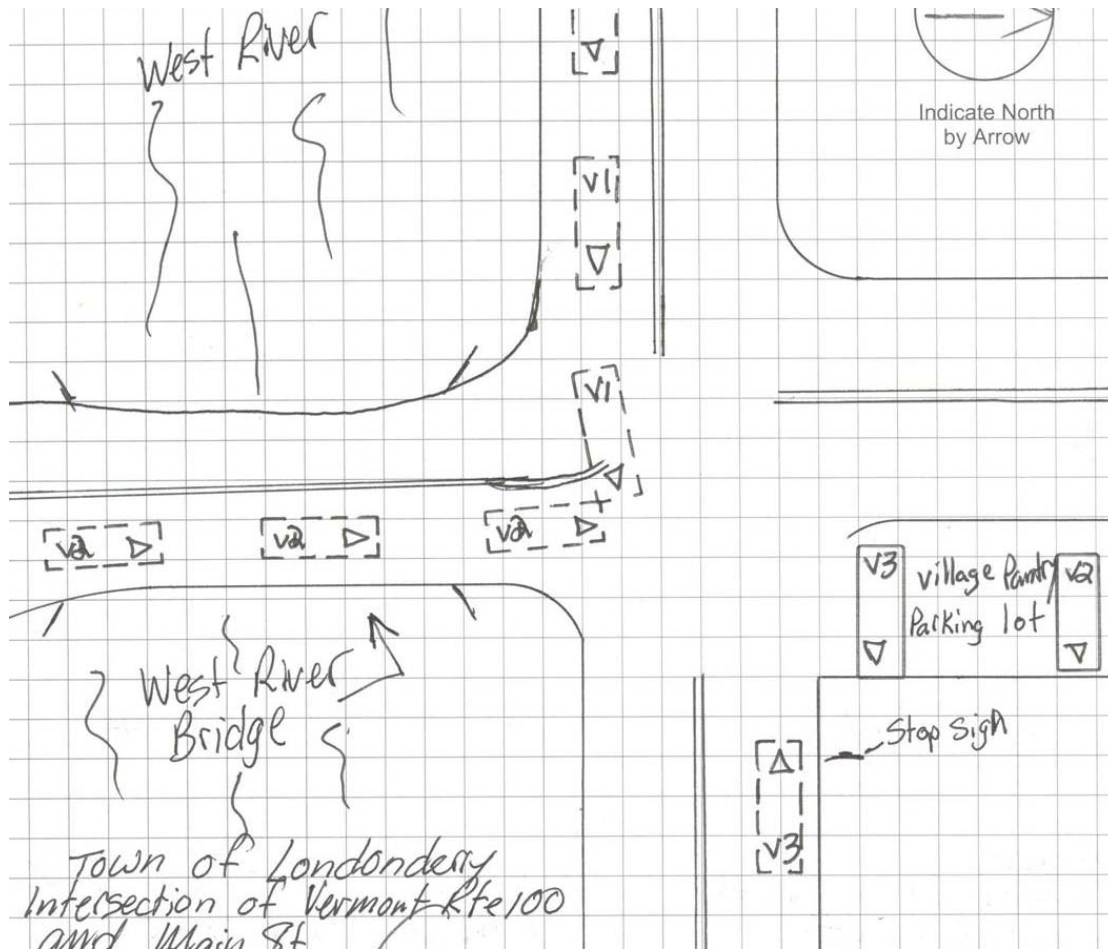
On September 28, 2013 at approximately 1518 hours, a three-car motor vehicle crash located at the intersection of Vermont Route 100 and Main Street. The weather at the time consisted of clear skies and the blacktop roadway was clear and dry. Operator # 2 advised he was traveling northbound on Route 100 at approximately 20 miles per hour. Operator # 2 advised as he was approaching the intersection of Middletown Road, he observed Vehicle # 1 traveling Southbound on Vermont Route 100. Operator # 2 advised Vehicle # 1 turned left off of Route 100 and onto Main St. Operator # 2 advised when Vehicle # 1 turned onto Main St. Vehicle # 1 failed to yield and crashed into Vehicle # 2. Operator # 2 advised after Vehicle # 1 crashed into Vehicle # 2, he observed Vehicle # 1 then crashed into Vehicle # 3, that was stopped at the stop sign at the intersection of Main St. and Route 100. Operator # 2 advised that he was unable to tell what Vehicle # 1's registration was, but could only provide that Vehicle # 1 was a blue pick-up truck, and that it continued to leave the scene north on Main St. and then onto Thompsonberg Rd. Operator # 3 advised he was stopped at the stop sign on Main St. and was waiting to safely turn south on Route 100. Before he made the turn, he advised he witnessed a blue pick-up truck, (Vehicle # 1), traveling southbound on Route 100. Operator # 3 advised he observed Vehicle # 1 then failed to yield to Vehicle # 2 before turning onto Main St., crashing into Vehicle # 2's front bumper and then bouncing off of Vehicle # 2 and into the front driver side fender of Vehicle # 3.

Operator # 3 advised he also witnessed Vehicle # 1 leave the scene of the crash and continue north on Main St. and continuing onto Thompsonberg Rd. Investigation revealed that Vehicle # 1 was traveling southbound on Route 100 approaching the intersection of Main St., when Vehicle # 1 failed to yield to Vehicle # 2 when he was traveling northbound on Route 100 at the same time. Vehicle # 1 then continued through the intersection glancing off of Vehicle # 3, causing minor damage to the front driver side fender.

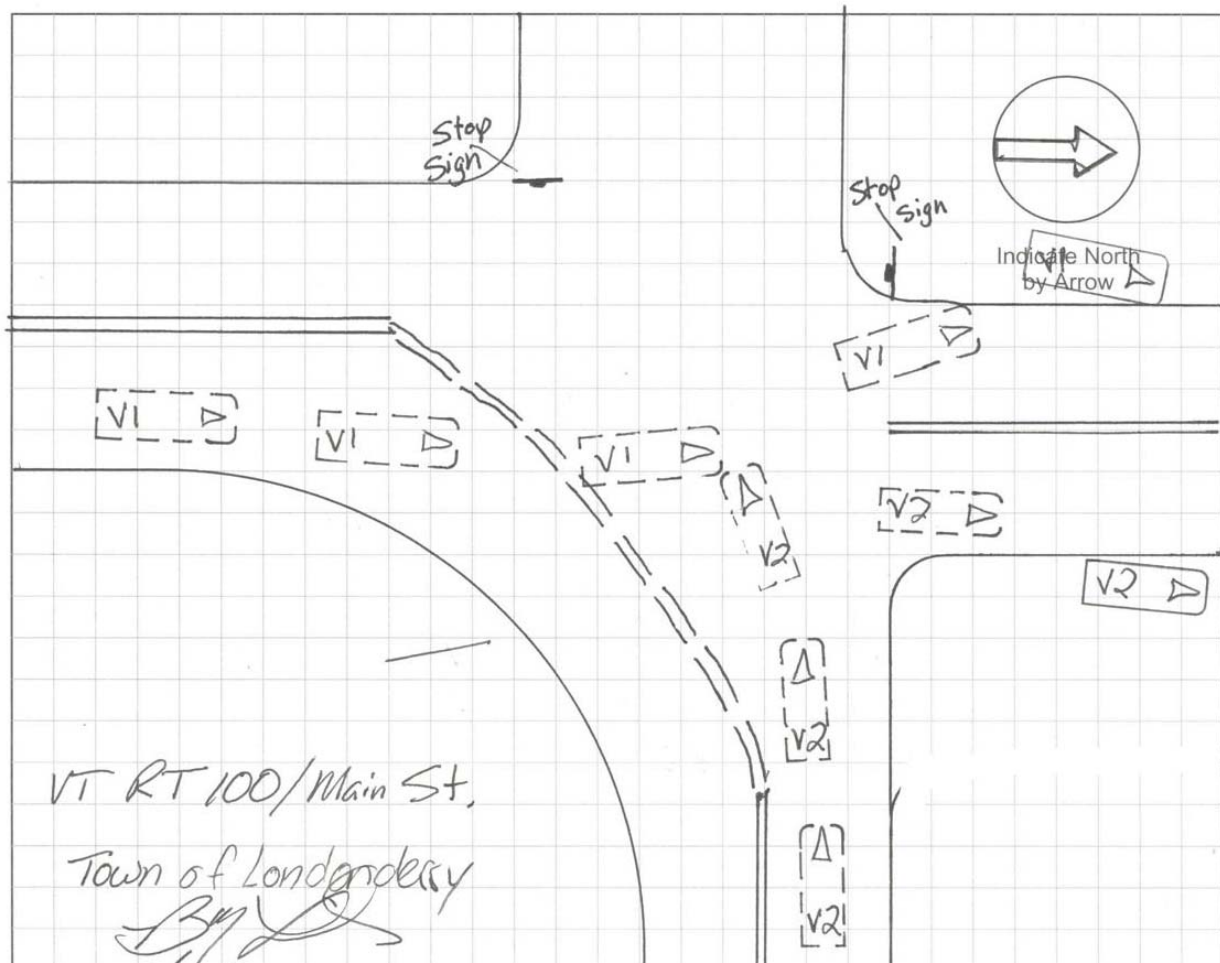
On August 22, 2015 at approximately 1642 hours, a two-car motor vehicle crash located at the intersection of Vermont Route 100 and Main Street, in the Town of Londonderry. Operator # 1 advised he was traveling southbound on Vermont Route 100 at approximately 35 miles per hour. Operator # 1 advised he was preparing to turn off Vermont Route 100 and onto Main Street. He advised he observed Vehicle # 2 traveling northbound. Operator # 1 advised he was going straight and felt he had the right of way. Statements- Operator # 2 advised he was traveling northbound on Vermont Route 100 at approximately 30 miles per hour, when he observed Vehicle # 1 traveling southbound. Operator # 2 advised she continued north and was then crashed into by Vehicle # 1. Investigation revealed that Vehicle # 1 was traveling south on Vermont Route 100. When Vehicle # 1 got to the intersection of Main Street, Vehicle # 1, turned left onto Main Street without yielding to Vehicle # 2 that was traveling north on Vermont Route 100.

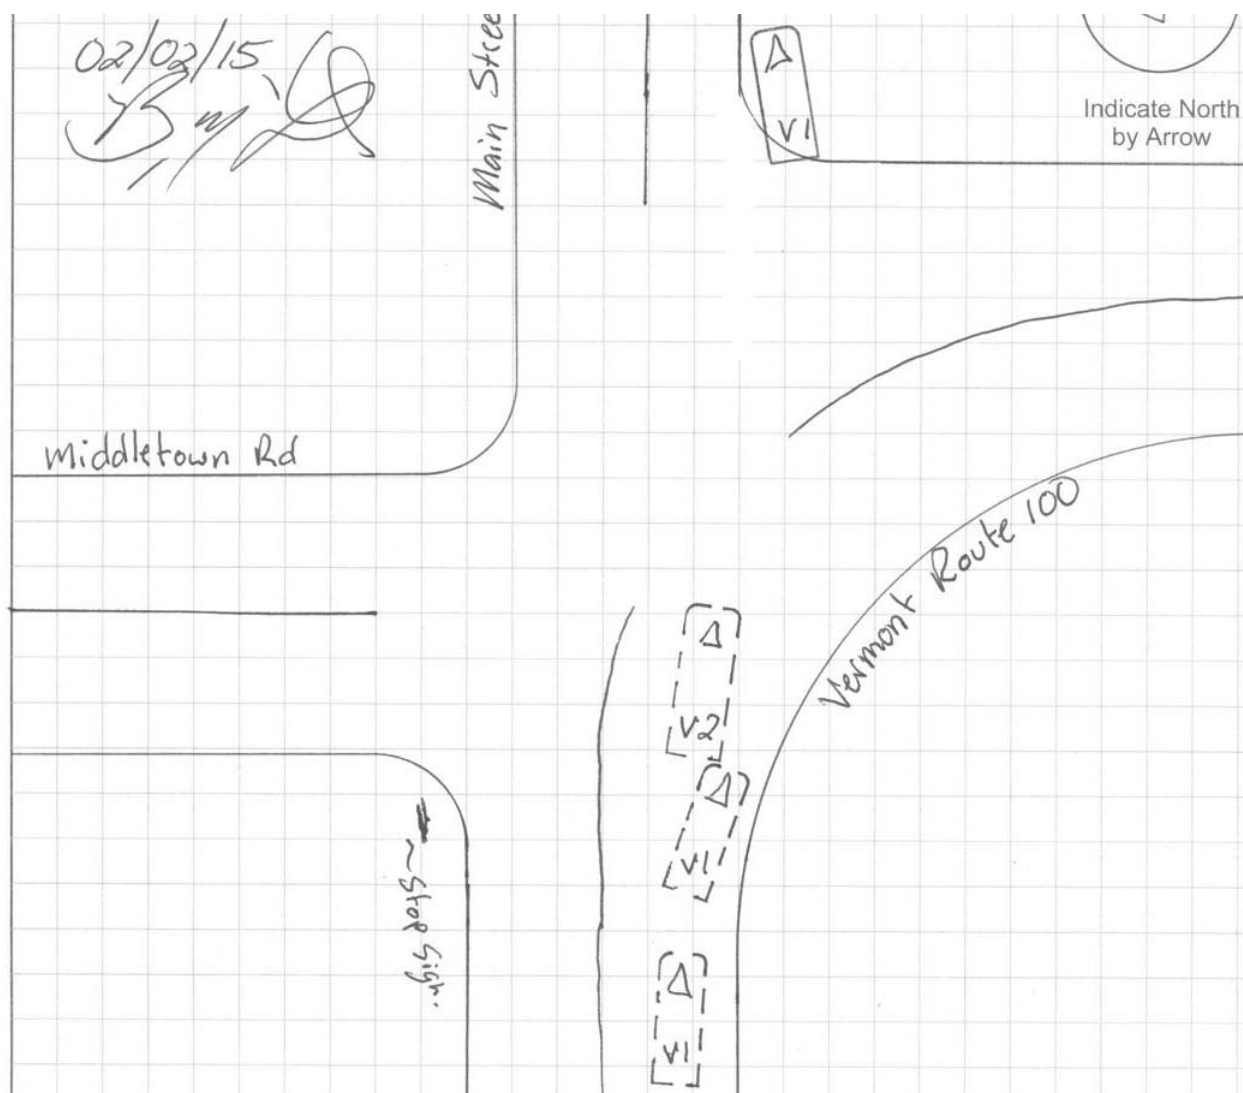
On February 2, 2015 at approximately 1741 hours, a two-car motor vehicle crash located at the intersection of Vermont Route 100 and Main Street, Operator # 1 advised she was traveling southbound on Vermont Route 100 at approximately 20 miles per hour, when she advised she observed Vehicle # 2 stopped with the left turn signal activated, waiting to turn left onto Main Street. Operator # 1 advised she attempted to stop, but was unable to stop due to the ice covered road surface causing Vehicle # 1 to crash into the rear of Vehicle # 2. Operator # 2 advised he was stopped on Vermont Route 100, waiting for northbound traffic to pass, and turn left onto Main Street. While waiting for northbound traffic to clear, he advised his vehicle was struck from behind by Vehicle # 1. Investigation revealed that Vehicle # 1 was traveling southbound on Vermont Route 100. As Vehicle # 1 was approaching the intersection of Vermont Route 100 and Main Street, Vehicle # 1 crashed into the rear of Vehicle # 2 that was waiting to turn left onto Main Street.
